ASSESSMENT, IMPACT AND CONTROL
OF SHORELINE CHANGE
ALONG NEW HAMPSHIRE'S TIDAL SHORELINE

UPDATE

by
Rockingham Planning Commission

September 1986

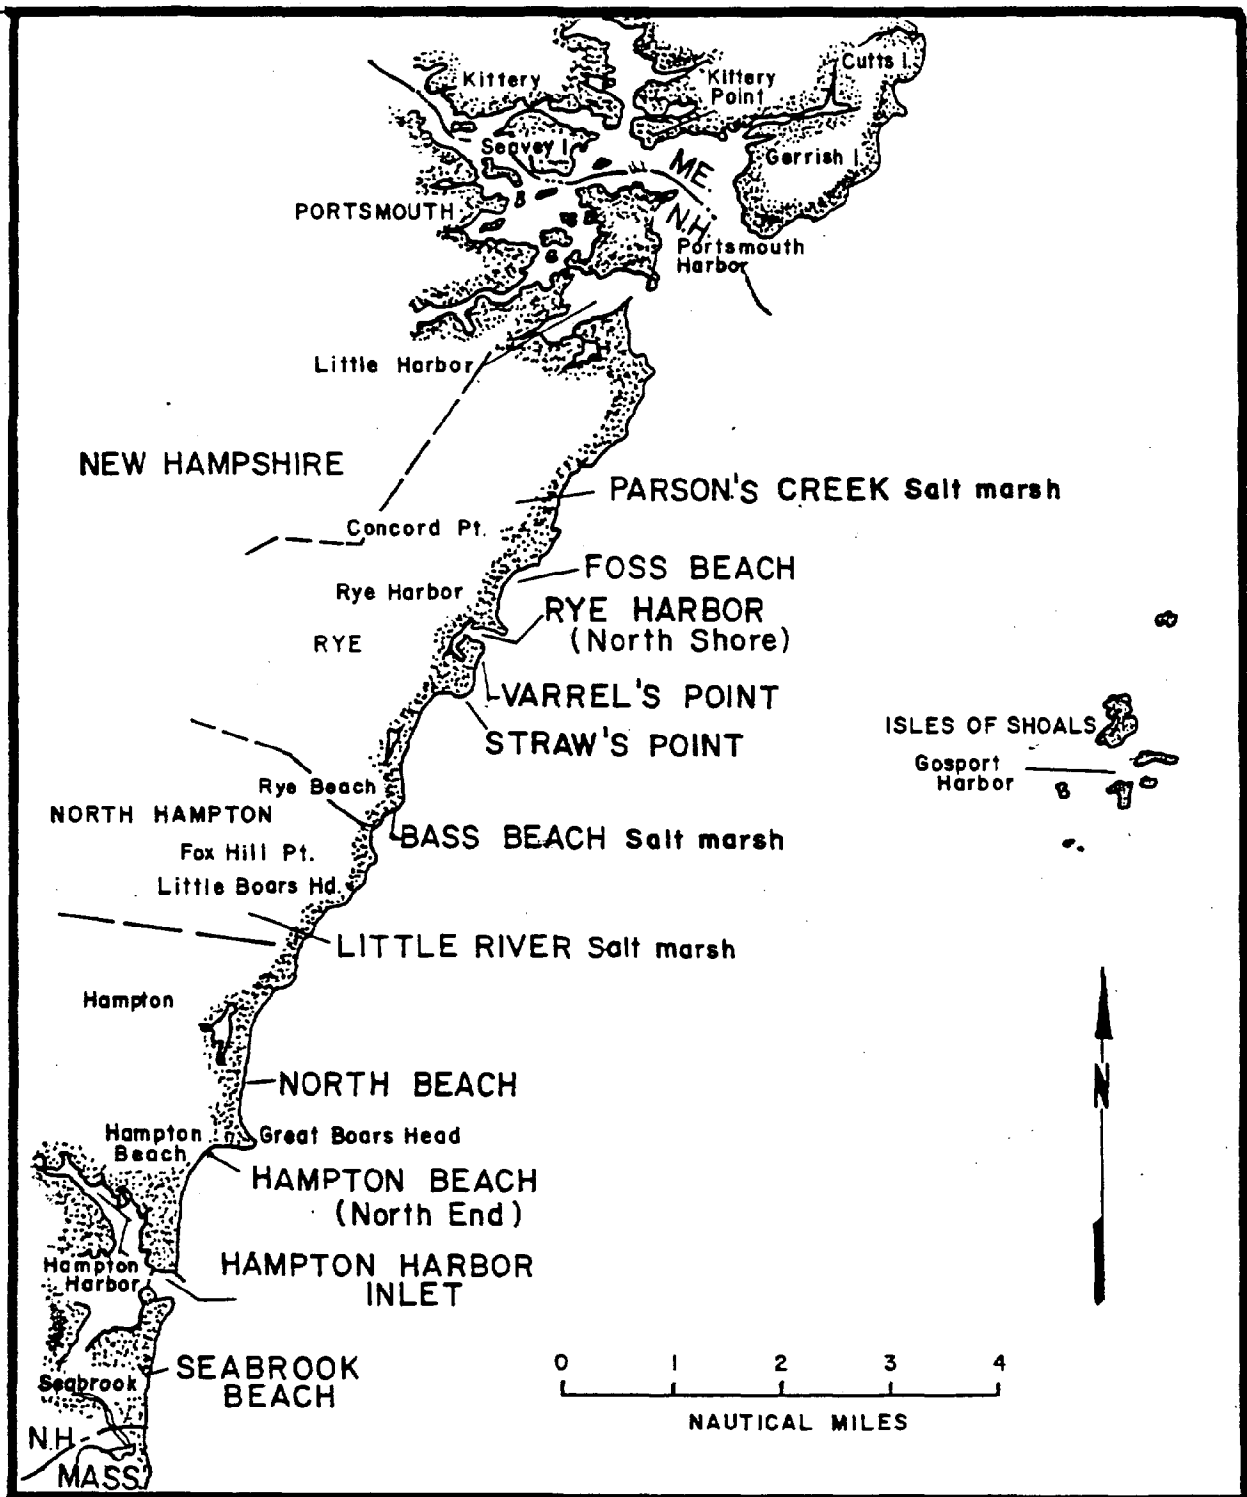
MAP 1

Areas Identified as those Experiencing Significant
Shoreline Change

Once the eleven areas were identified, (See Map 1) the most recent data was utilized to describe existing conditions. Following this, an engineering consultant's service was procured to recommend mitigation measures -- with cost estimates -- for each of the 11 locations.

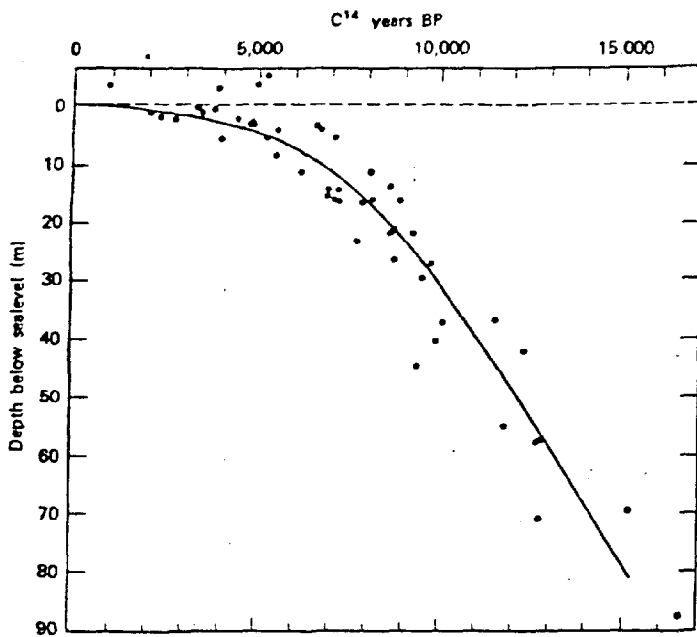
Figure 12-3. Submergence curve based on nearly 50 C^{14} -dated samples of oysters taken from growth positions judged to have been close to sealevel. Samples are from various depths along or off several coasts thought to have been relatively stable. C^{14} ages are plotted against depths. Curve reflects progressive submergence, believed to be chiefly eustatic. Compare a similar curve for the Netherlands constructed by Jelgersma (in Sawyer, ed., 1966, p. 62) and the curve in Milliman and Emery, 1968, fig. 1; also fig 12-2. (After Shepard, 1963b, p. 1, 2.)

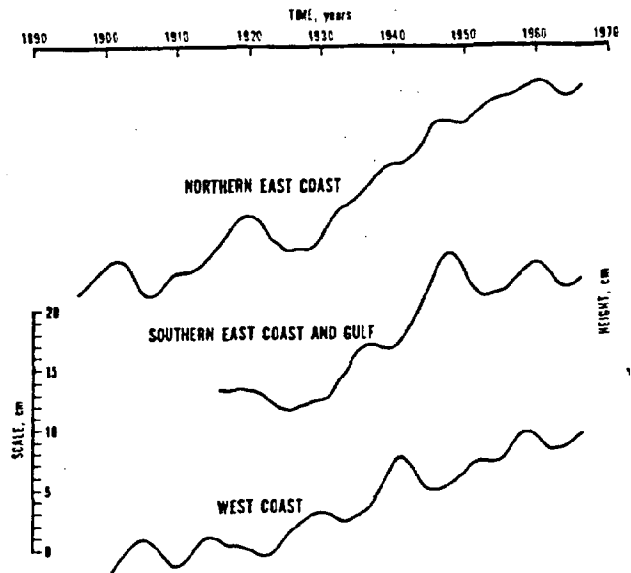
Fig. 10. Averaged damped series classifying United States sea level characteristics into Northern East Coast Area (north of Cape Hatteras), Southern East Coast and Gulf Area (south of Cape Hatteras), and West Coast Area.

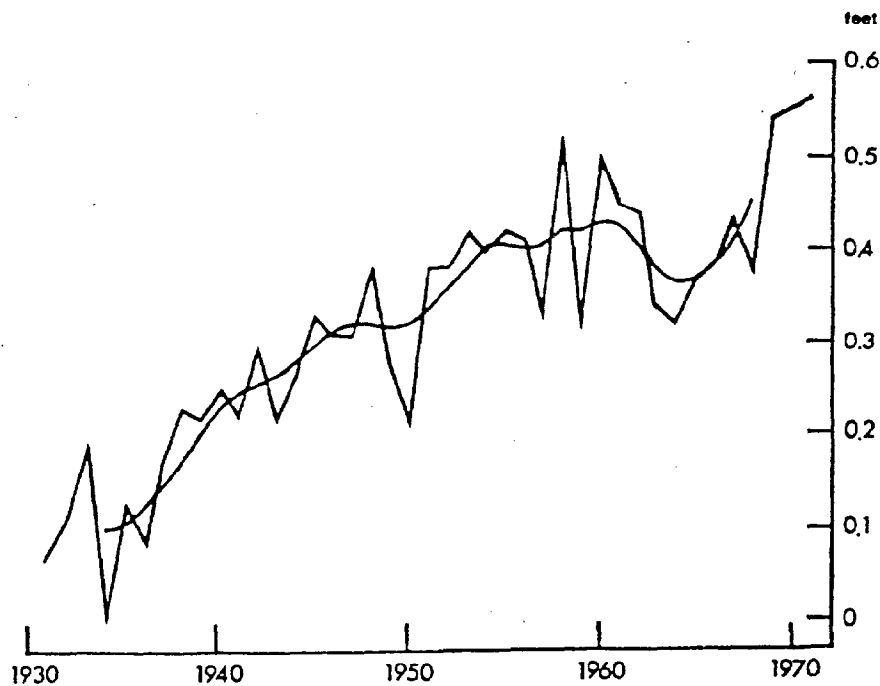
FIGURE 1

Figure 13: Yearly mean sea level at Newport, Rhode Island.

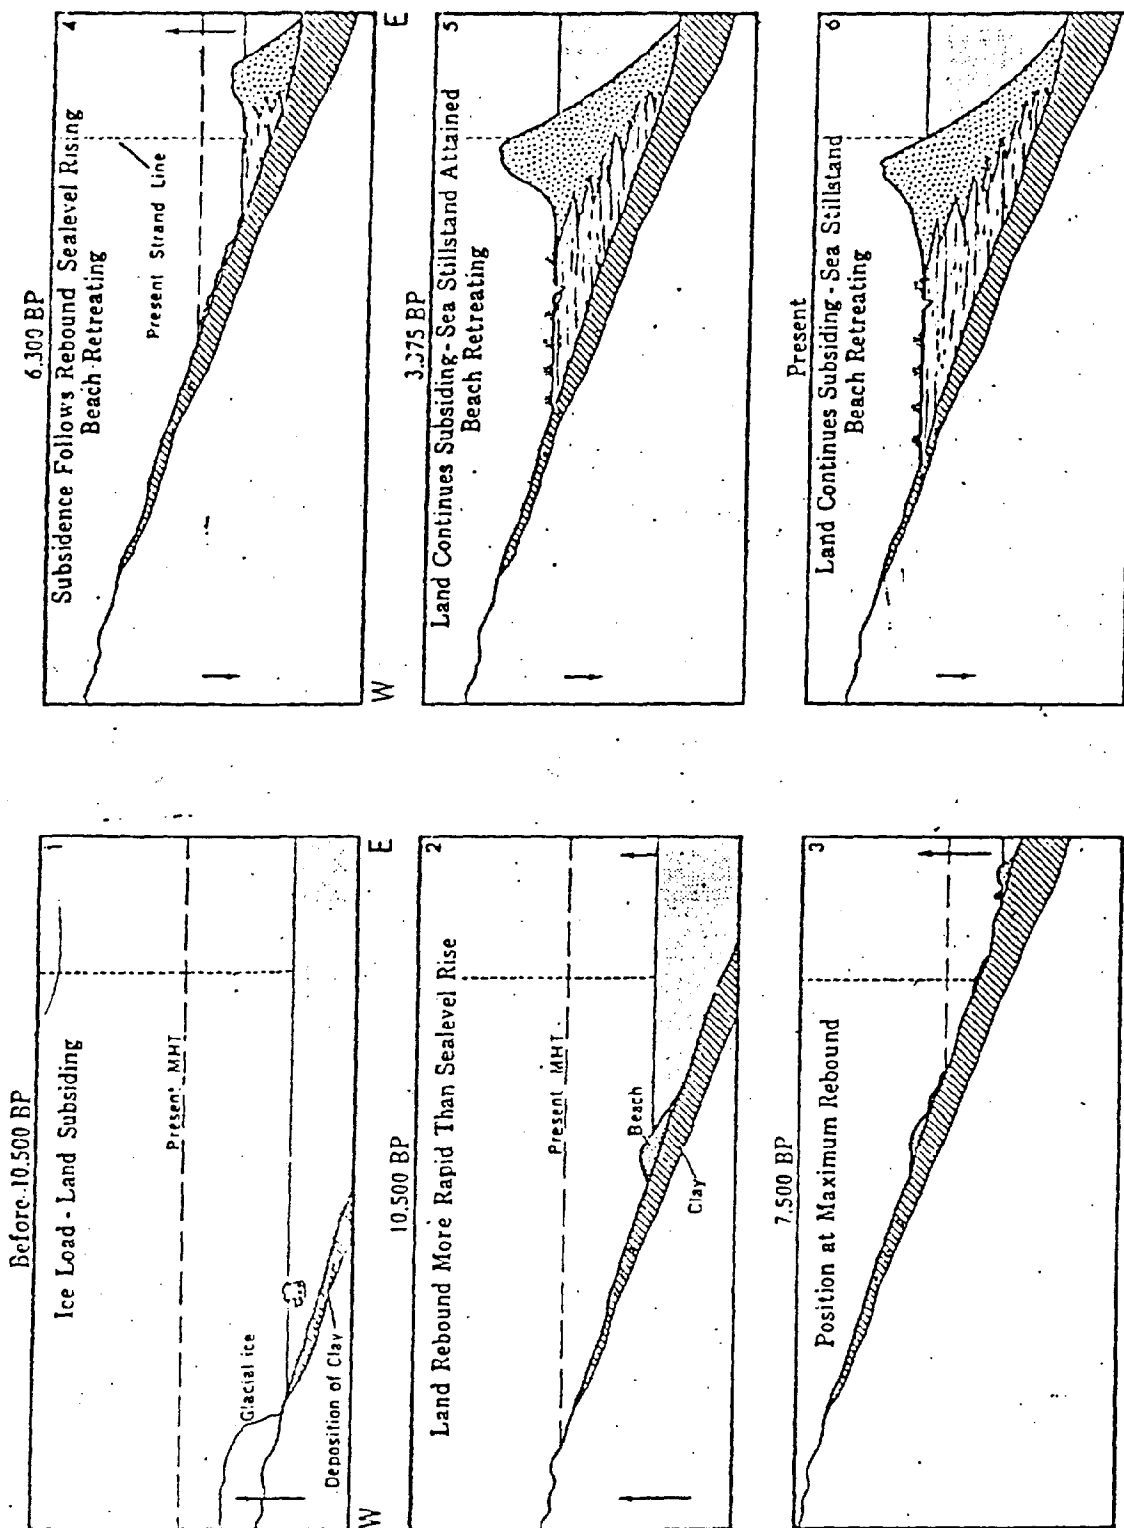
Fig. 10. Plum Island strandline changes and beach development is correlated with relative changes of level for the past 11,000 years. Direction of strandline displacement is shown by the position of the vertical dashed line.

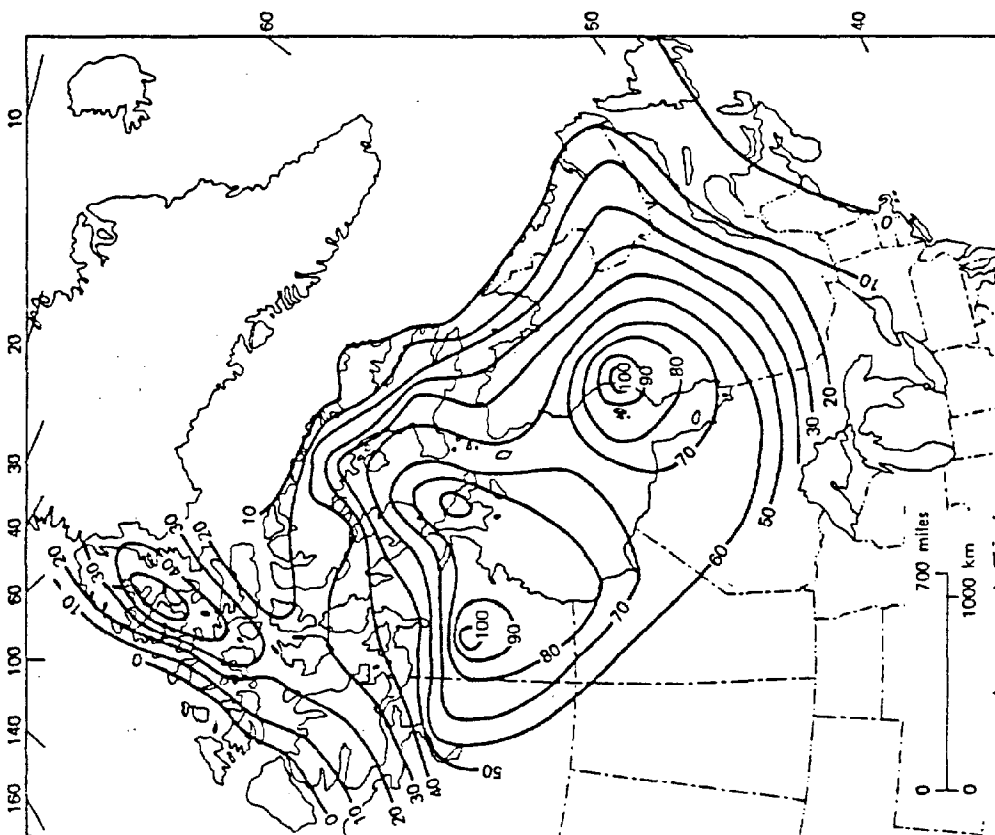
FIGURE 3

Figure 13-13 Isobases, plotted by a technique described by Andrews (1968b), from occurrences of postglacial marine sediments at 58 points in eastern and northern Canada where date and altitude of each occurrence are known. The curves are based on the sealevel of ~6000 BP, believed to be ~13m below that of today (Shepard, 1963b, fig 1). They show amplitude of emergence in meters $\pm 5m$, since that date. Three centers of uplift are evident, possibly reflecting the positions of comparatively thick residual ice bodies shortly before the date mentioned. (J. T. Andrews, unpublished.)

Crustal depression as a result of the weight of the ice occurred in New Hampshire. Depression depended on the amount of overlying ice and hence decreased with distance from the core of the glacier. The relationship between ice thickness and crustal depression was roughly three to one (Flint, 1971). Here in New Hampshire, depression has been estimated at 40 feet (McIntire and Morgan, 1964). Today, rebound of the crust is complete (see Figure 3).

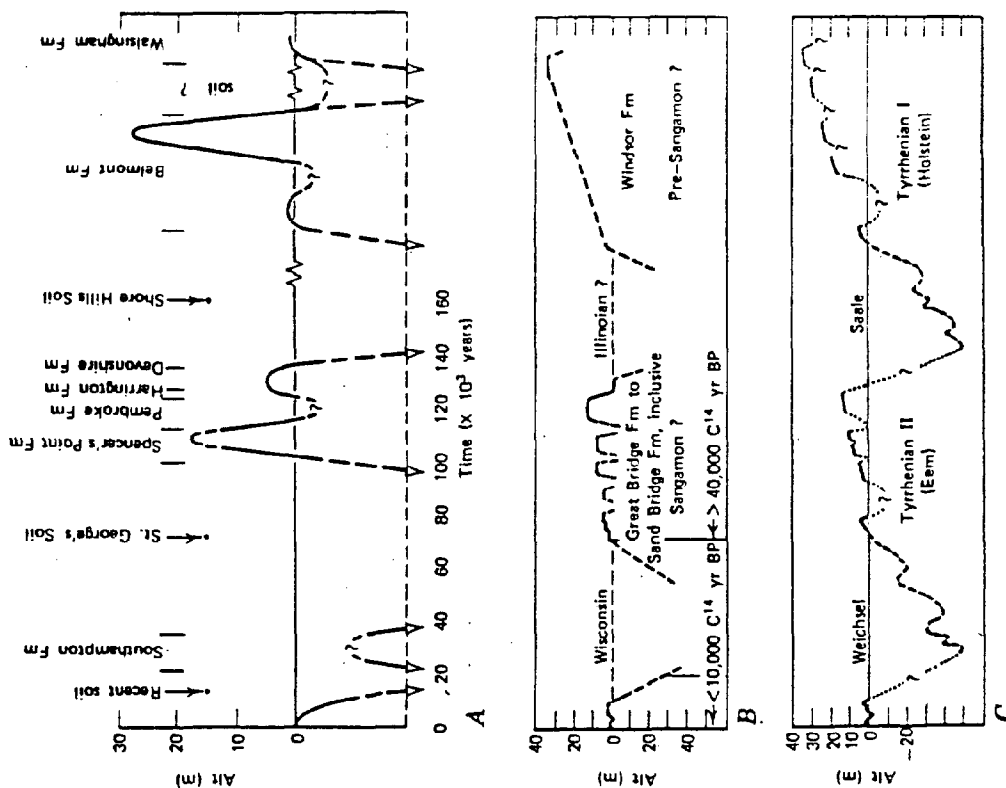
Figure 12-9 Generalized curves showing inferred fluctuations of relative sea level through time in three areas. A. Bermuda (After Land et al., 1967, p. 1002). Time calibration, based in large part on U-series dates, is by those authors. B. Norfolk district, Virginia (Oaks, 1965, with unpublished changes). C. Southern Mallorca (After Butzer and Cuerda, 1962, p. 414). Correlations are by those authors.

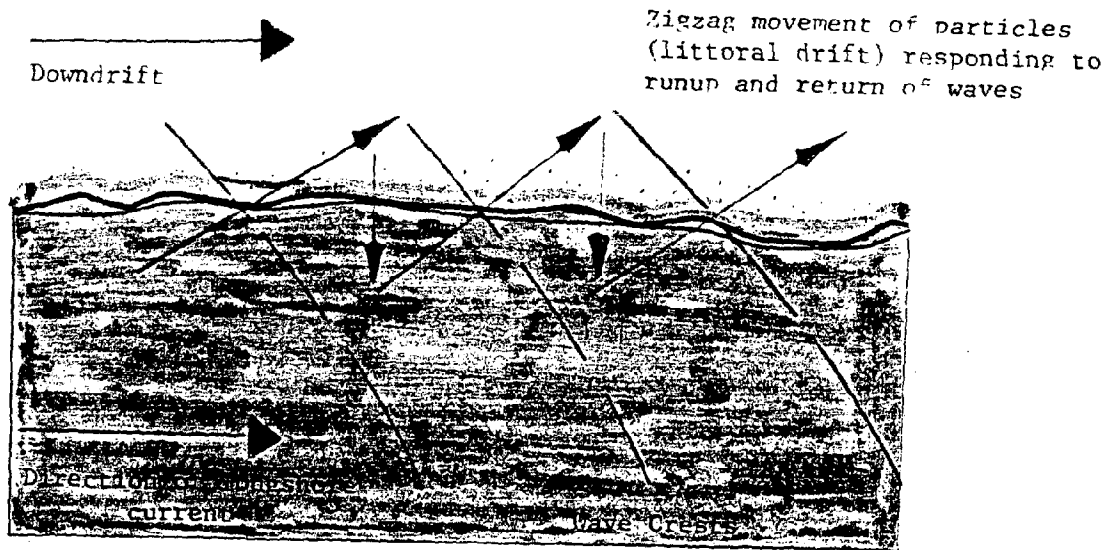
FIGURE 4 -- Longshore Transport of Sediments

Wave motion, particularly that of breaking waves, is the most important active agent in beach building and erosion. As the waves break, run up the shore, and return, they carry sedimentary material onshore and offshore. Most waves arrive at an angle to the shore and set up a longshore current, moving sediments in a series of zig zags as successive wave fronts advance and retreat. The predominant direction of longshore transport is referred to as "downdrift" (See Figure 4).

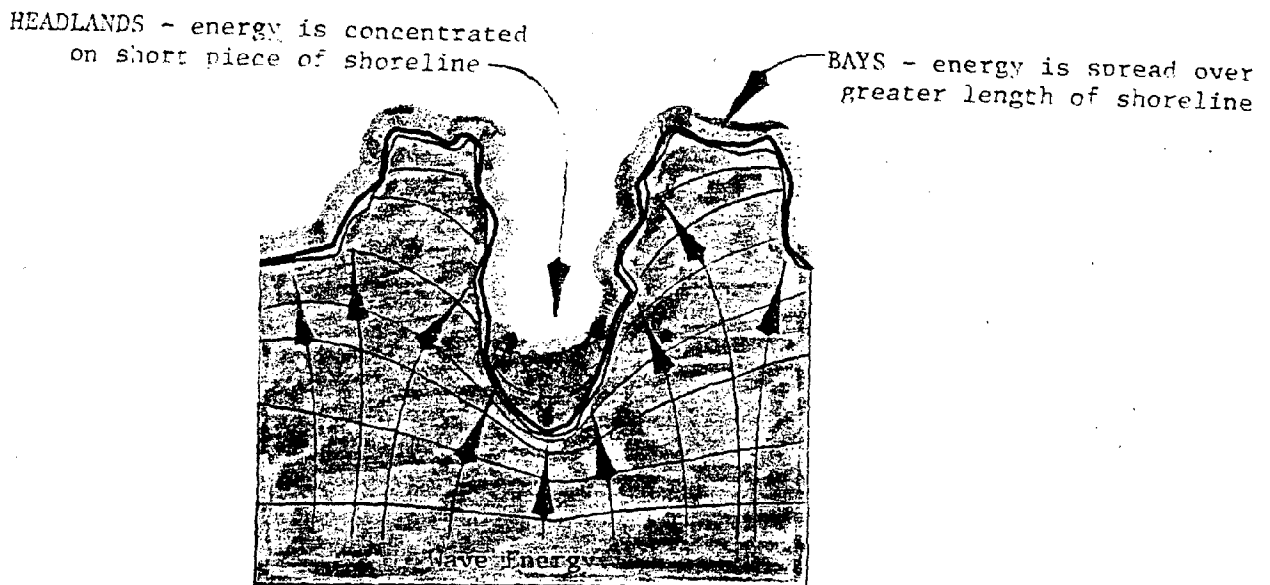
FIGURE 5 - Concentration of Wave Energy Around Headlands

Parts of the shore that extend into the water are more vigorously attacked than the shoreline inlets and bays. Incoming waves tend to bend, or are "refracted" around these peninsulas, headlands, extended beaches, and concentrate their energy on the front and sides of these areas (See Figure 5). Consequently, a current is established toward the beaches from the headland. This flow, of course, depends on the approach of the incoming waves. Wave approach from the north results in a net transport of beach material to the south end of the beach;

southerly waves produce transport to the north. The dominant direction of transport is, however, from headlands toward beaches.

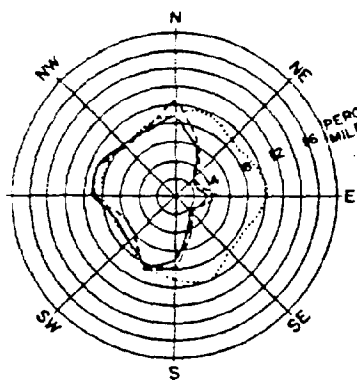
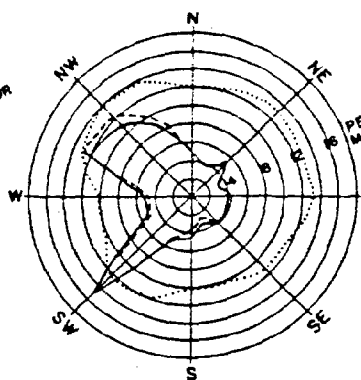
WIND DIAGRAMS

OCTOBER 1949 - SEPTEMBER 1952, INCLUSIVE

BASED ON HOURLY DURATION OF WIND SPEED AND DIRECTION OBSERVED BY U.S. WEATHER BUREAU

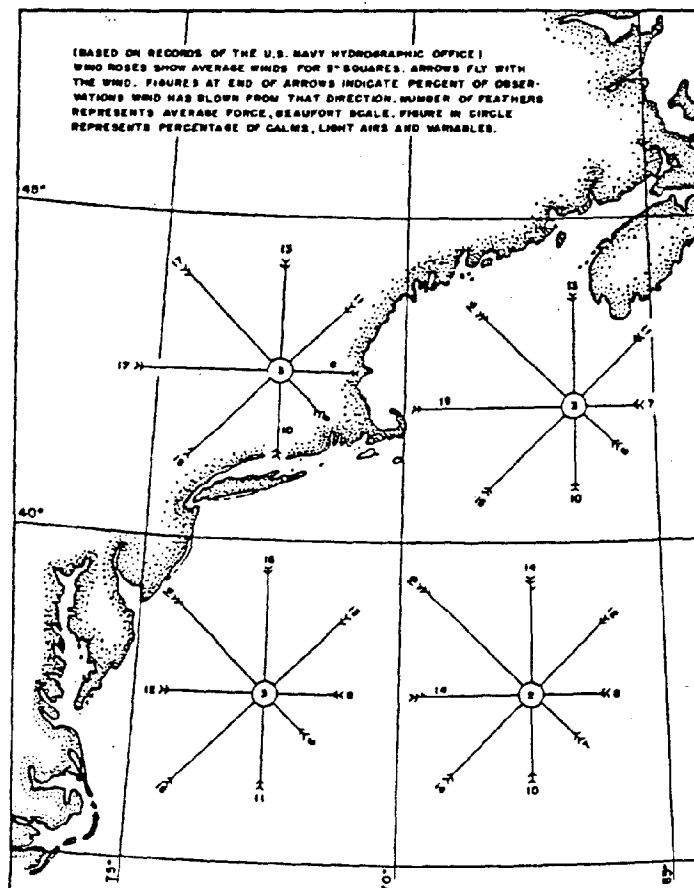
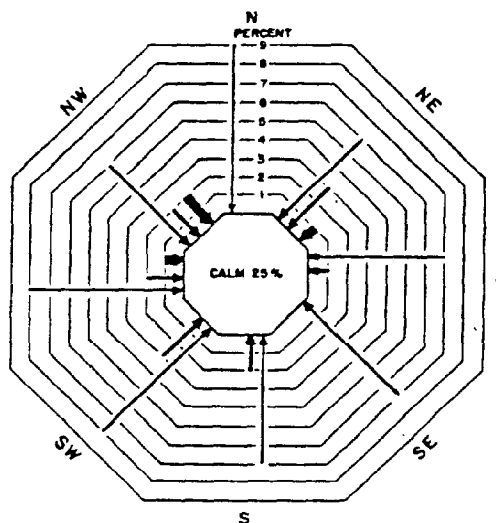
WAVE DIAGRAM-OFF PENOBSCOT BAY

SHOWING PERCENT OF TIME WAVES OF DIFFERENT HEIGHT OCCUR FROM EACH DIRECTION
 HINDCAST FROM SYNOPTIC WEATHER CHARTS FOR THREE YEAR PERIOD 1948-1950

— LOW SWELLS—(1-6 FT.)
 — MEDIUM SWELLS—(6-12 FT.)
 — HIGH SWELLS—(OVER 12 FT.)

ARROWS INDICATE THE COURSE OF SWELLS. LENGTH OF BAR DENOTES PERCENT OF TIME THAT SWELLS MOVED FROM OR NEAR GIVEN DIRECTION. FIGURE IN CENTER OF DIAGRAM INDICATES CALMS. SWELL DATA BASED ON OBSERVATIONS FOR 10 YEAR PERIOD, 1932-1942 IN THE AREA BORDERED BY THE SHORELINE, LINES OF LONGITUDE 65° AND 70°, AND LINE OF LATITUDE 40°.

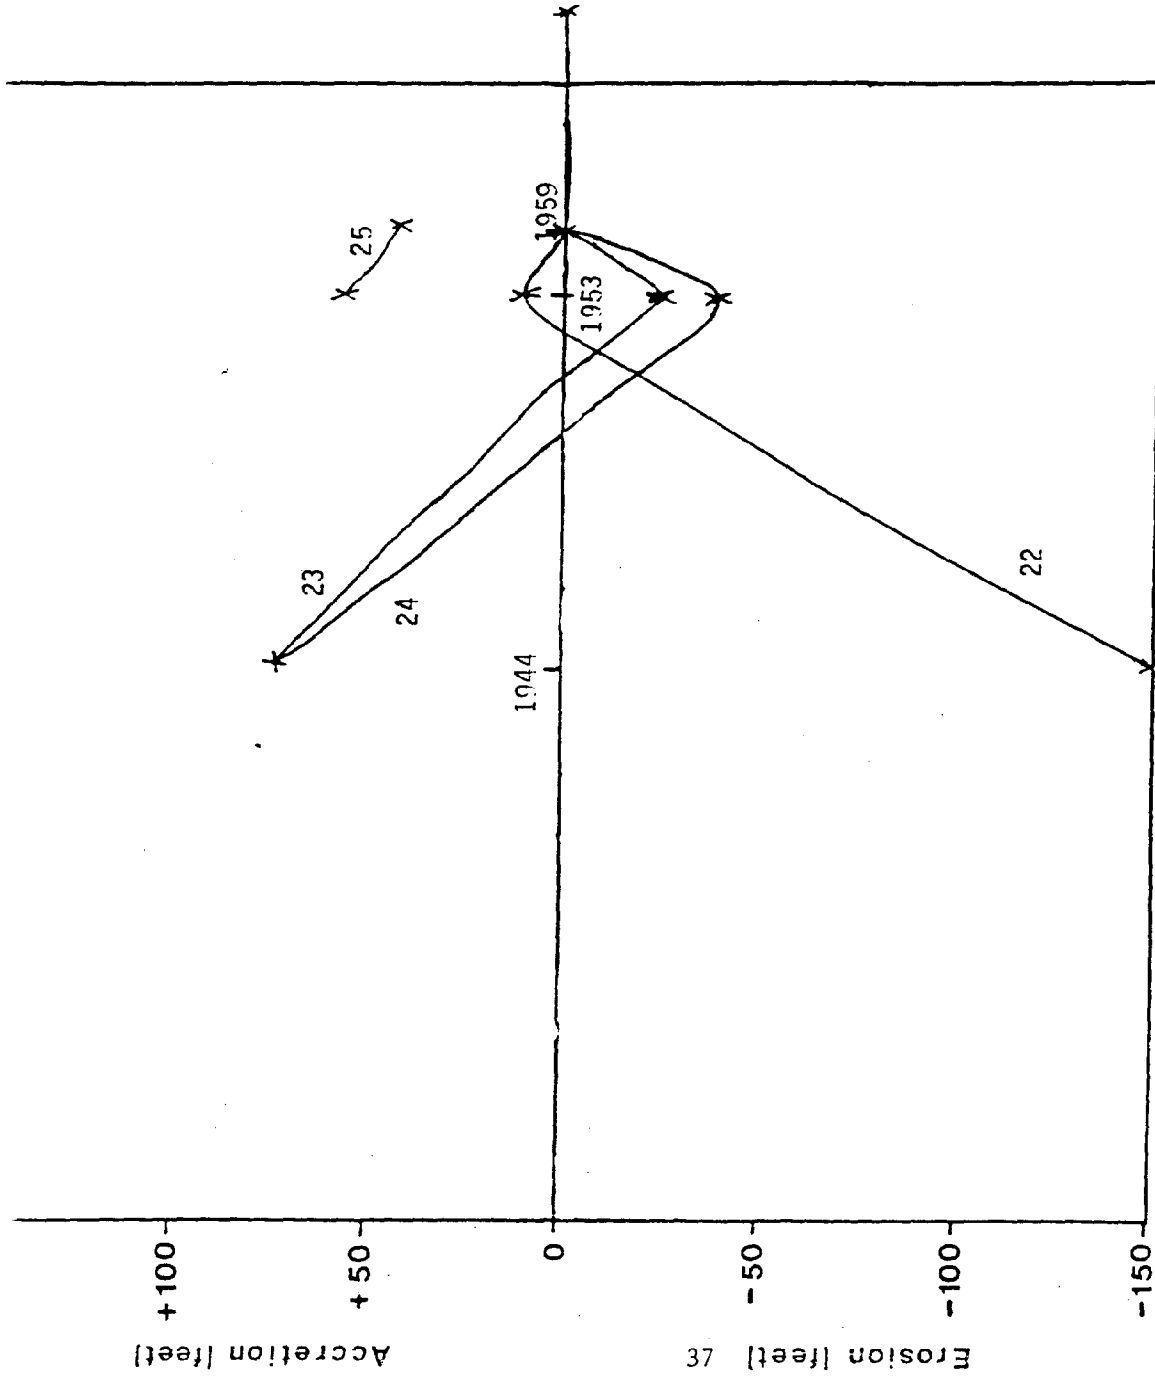
GRAPH 5

<u>Interval</u>	<u>Change (feet)</u>
Ragged Neck, Rye	1866-1944	-150
	1944-1953	+15
	1953-1957	0
Foss Beach, Rye	1866-1944	+75
	1944-1953	-25
	1953-1959	0
	1959-1973	0
Rye North Beach	1866-1944	+75
	1944-1953	-35
	1953-1959	0
Wallis Sands, Rye	1944-1953	+75
	1953-1959	+50

SHORELINE CHANGE GRAPHS

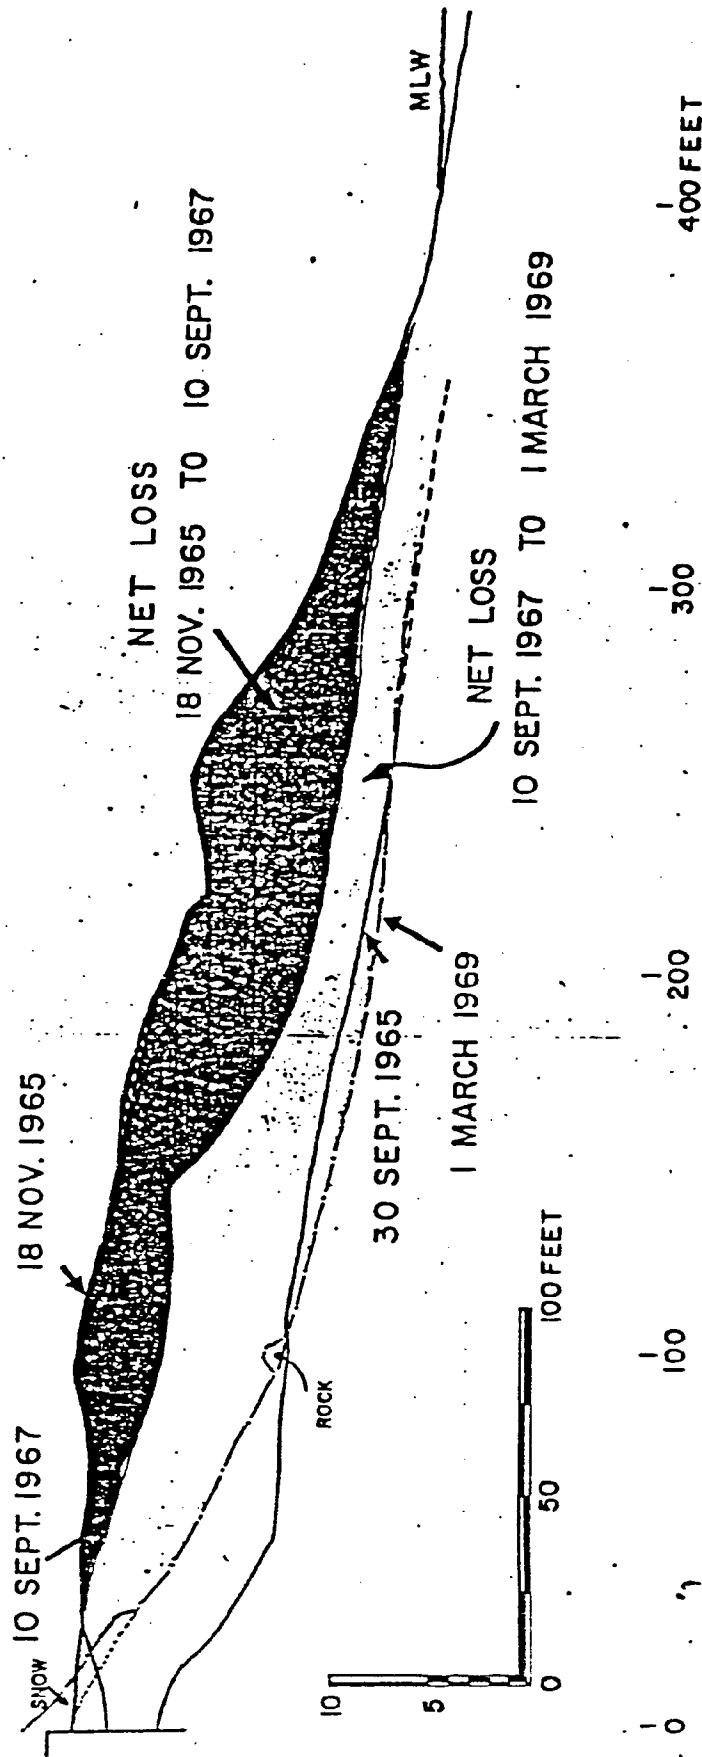
FIGURE 9 SOURCE: Hayes, 1969

BEACH PROFILES STATION HBB, HAMPTON BEACH HAMPTON, N.H.

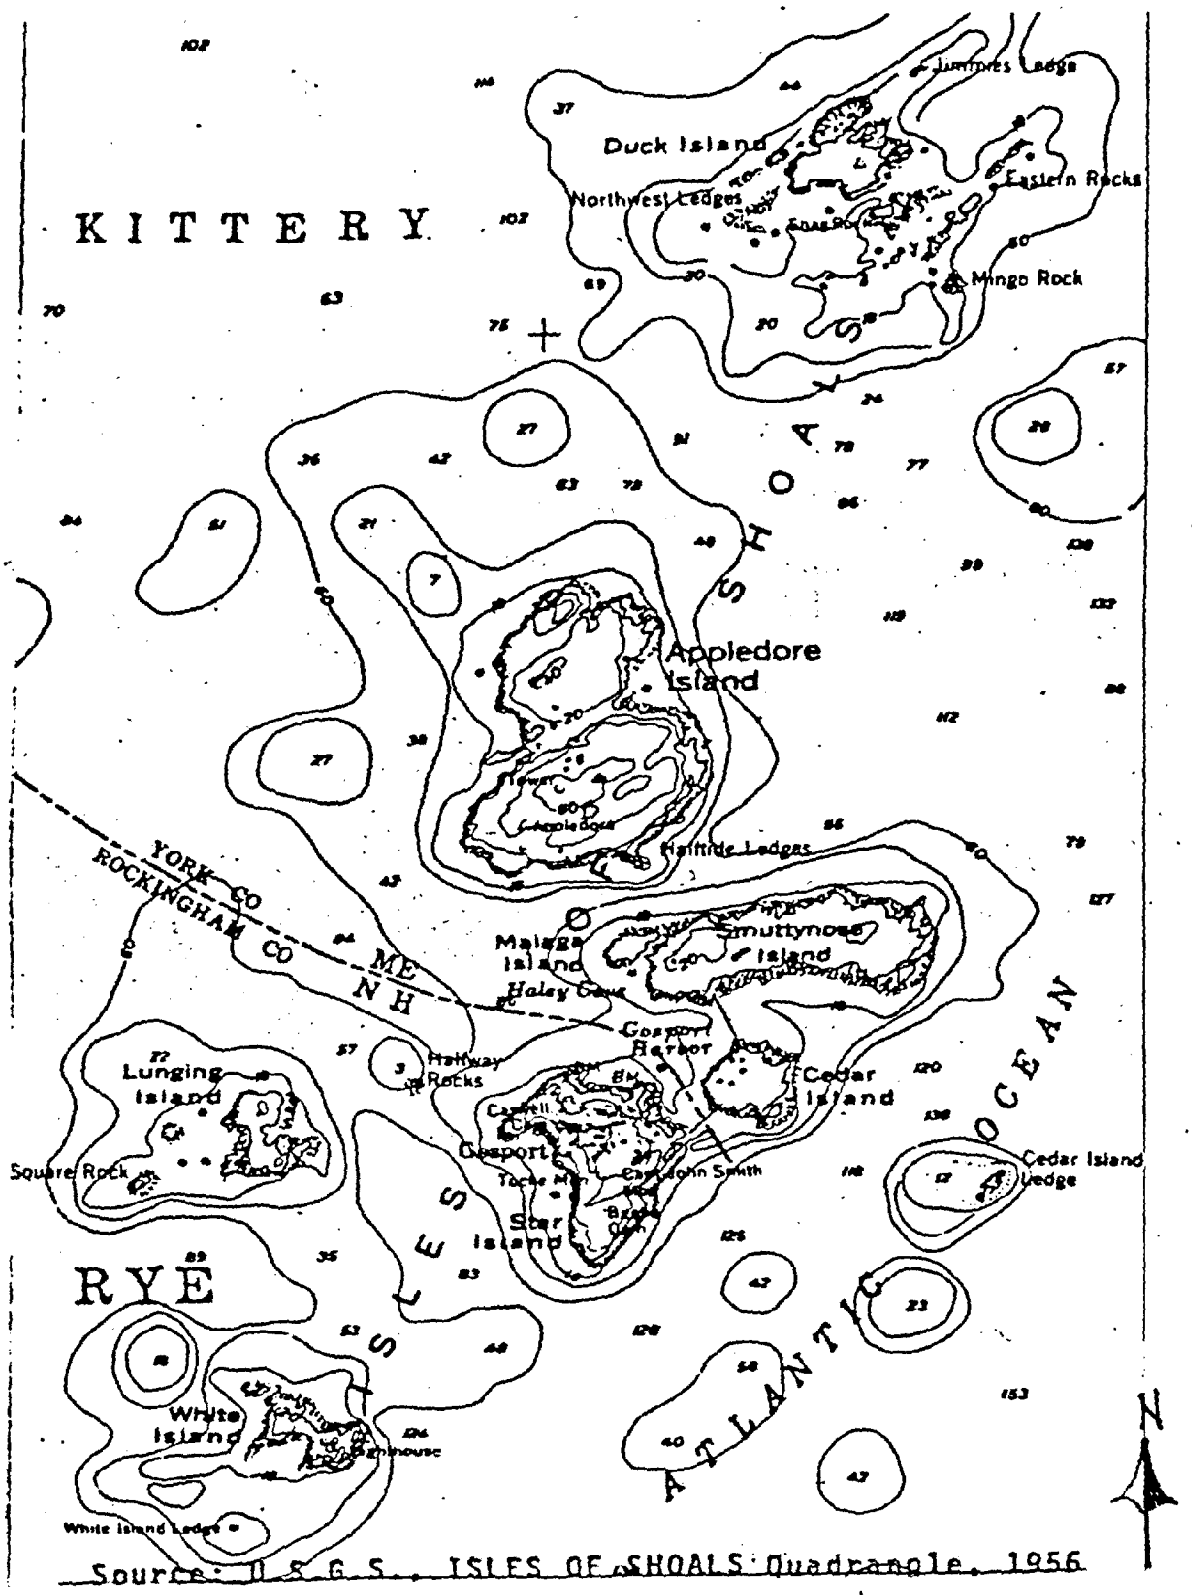
MAP 12

Source: U.S.G.S. ISLES OF SHOALS Quadrangle, 1956

The Isles of Shoals lie seven miles off the coast of New Hampshire (See Map 12, page 88). They are divided by the Maine-New Hampshire state boundary, with Star Island, Lunging Island, and White Island located in New Hampshire. These are small islands. The largest in New Hampshire, Star Island, is .5 miles long.

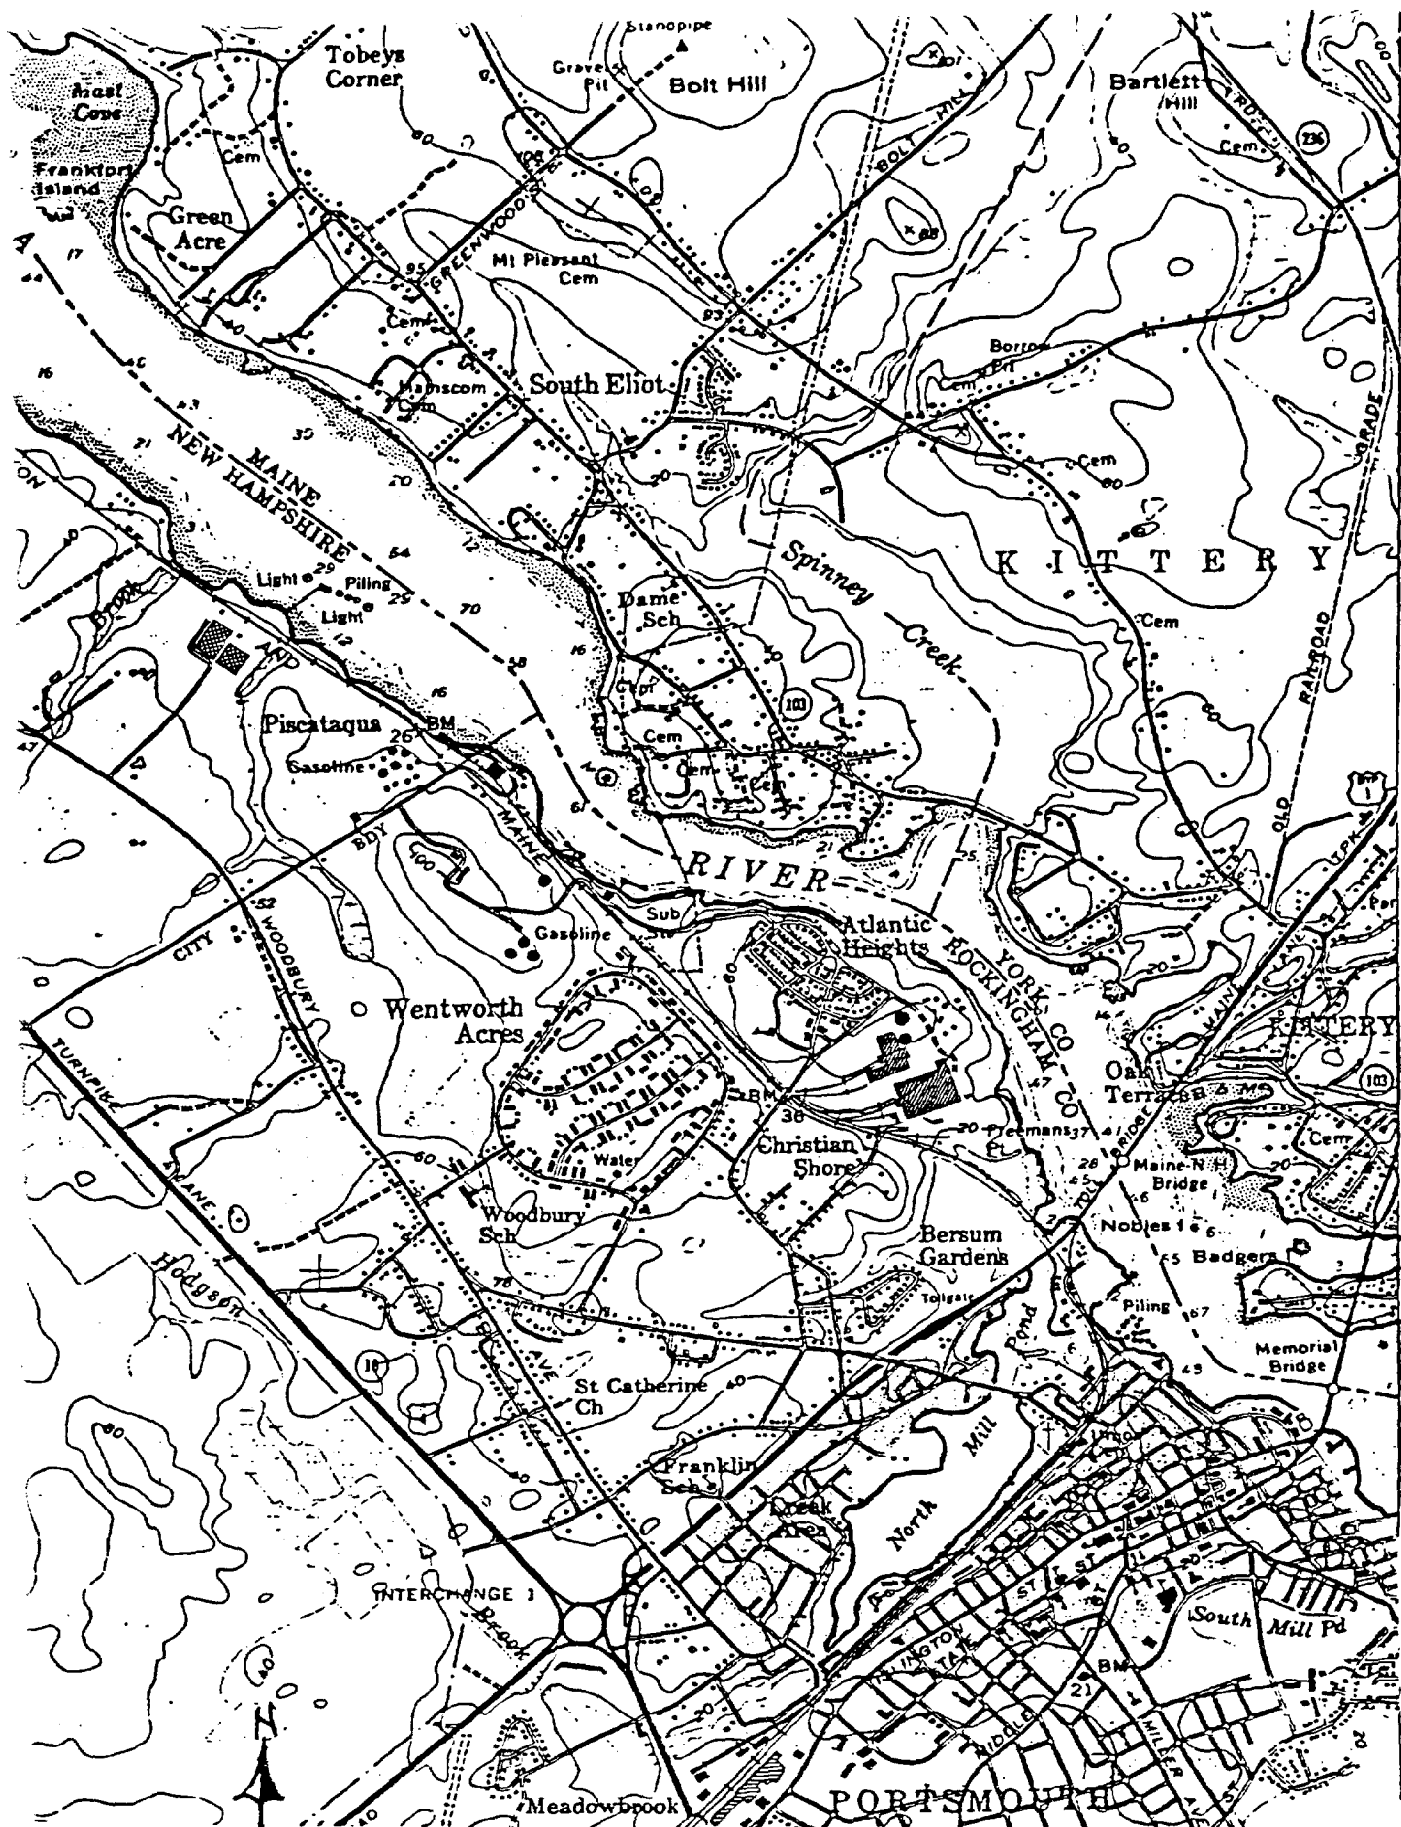
SOURCE : USGS Portsmouth, N.H. Quadrangle

The Piscataqua River occupies a drowned river valley and extends from the confluence of the Salmon Falls and Cocheco Rivers in Dover to the sea in Portsmouth (See Map 13, page 90). The river is under tidal influence for its entire length, as are, for a limited distance, its two tributaries. The Piscataqua River is the means by which sea water enters the Great Bay estuary.
